Clutch Diagnosis - Causes of Failure

**Guide Tube wear, Spline wear,
Mainshaft Bearing wear**

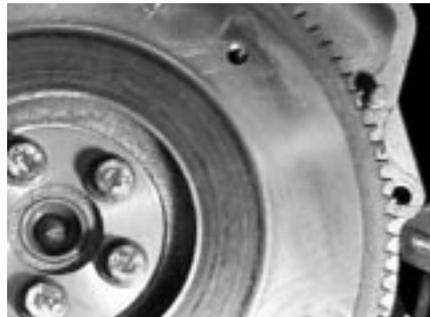
**Worn Flywheel Bearing, ridged
or heat damaged Flywheel surface**

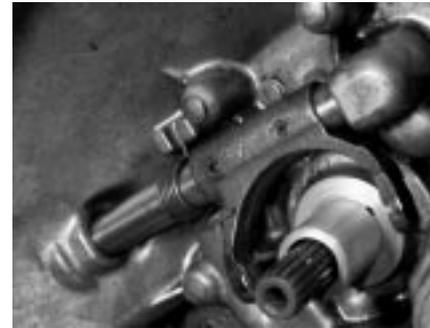
**Worn/siezed Release Arm pivots,
friction lining dust contamination
to greased components**

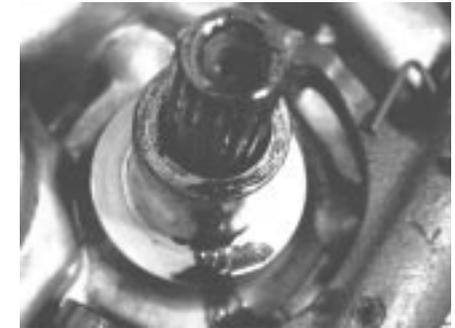
**Transmission and engine
oil leaks
(contaminating Friction Linings)**

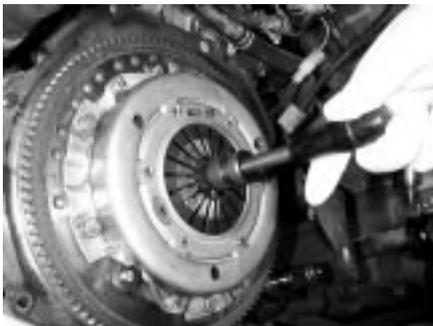
**Incorrect alignment of clutch Disc
or damage caused during incorrect
fitment of transmission**

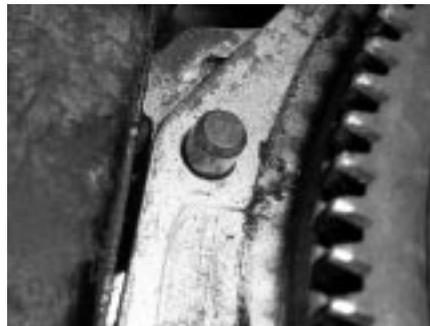
**Damage or removal of
Transmission Dowels**

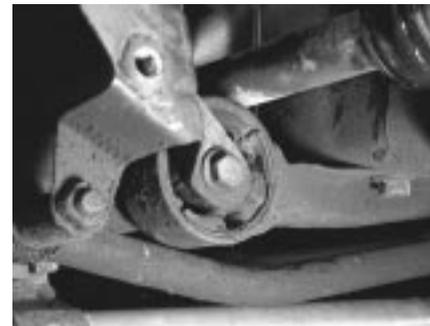
**Worn drive train components or
engine misfire.
(e.g.Engine mounts, CV Joints.)**

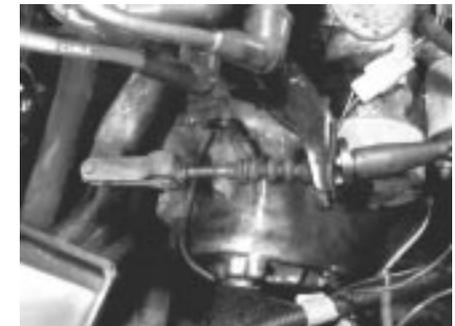
**Incorrect or insufficient clutch
adjustment, worn clutch cables,
faulty hydraulic systems**

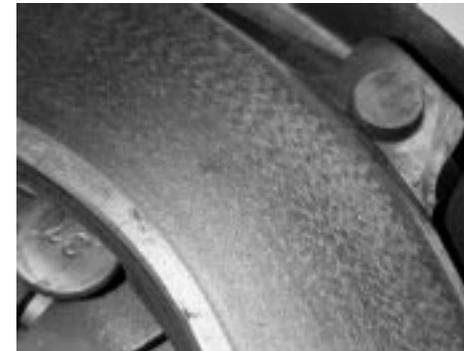
7) & 8) CLUTCH COVER PRESSURE PLATE HEAT DAMAGE

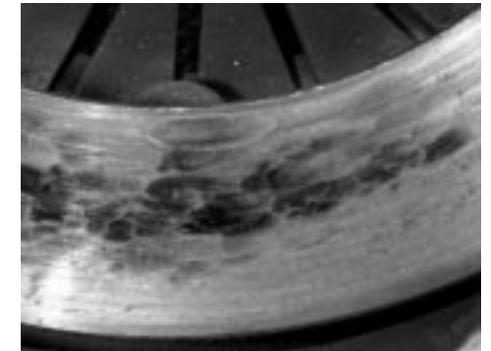
Please refer to text boxes below for further details

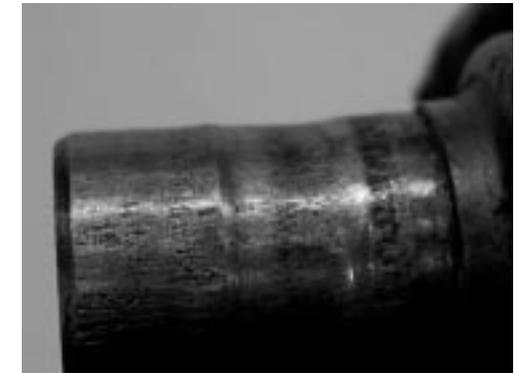
**3) WORN TRANSMISSION
GUIDE TUBE**

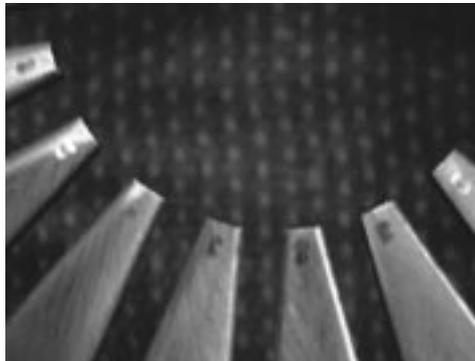
**4) LIGHT BEARING WITNESS
MARKS ON COVER FINGERS**

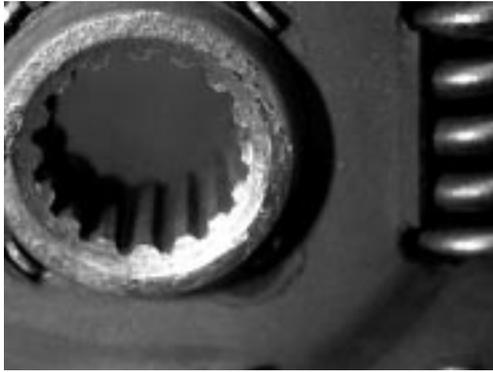
**1) DAMAGED INPUT AND
TAPER SPLINE ENDS**

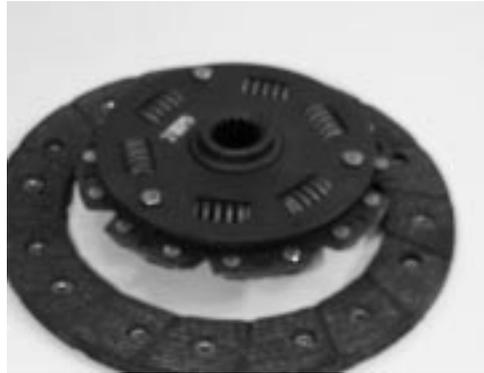
2) DRIVE PLATE FRACTURE

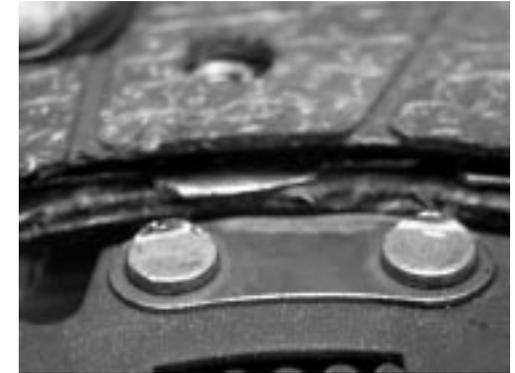
3) DRIVE PLATE FRACTURE

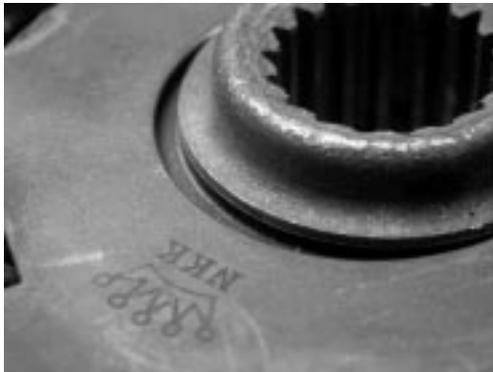
**4) AXIAL WEAR OF THE SPLINE BOSS IN
THE CLUTCH DISC HUB ASSEMBLY**

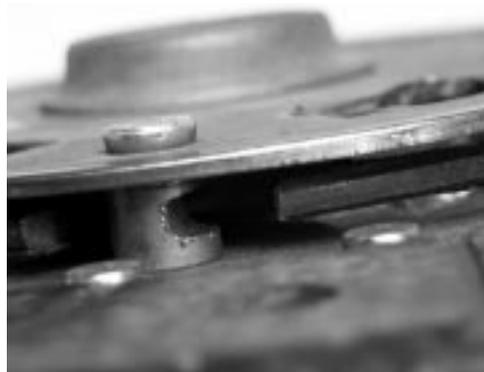
5) HUB RETAINING RIVET WEAR

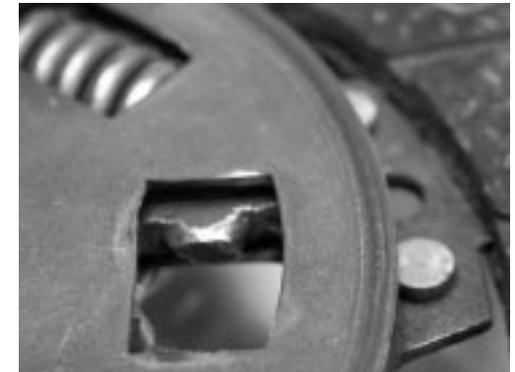
6) BROKEN DAMPER SPRING

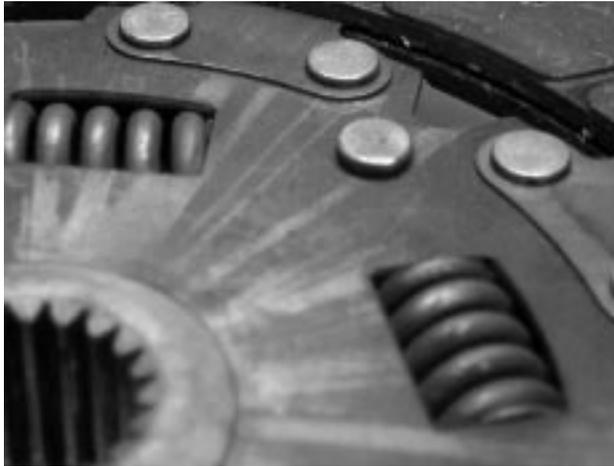
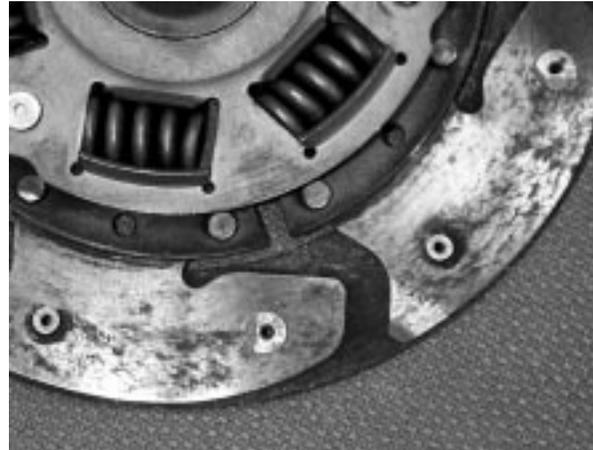
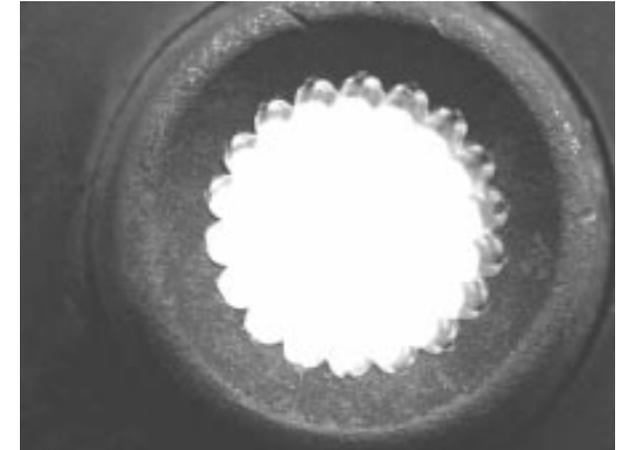
Spline Grease Contamination of Friction Linings

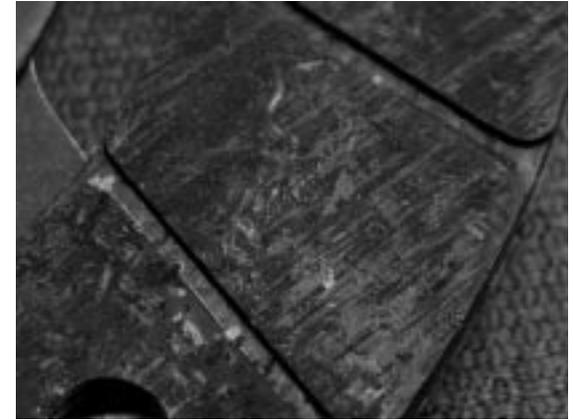
Burnt Lining- Prone to Judder

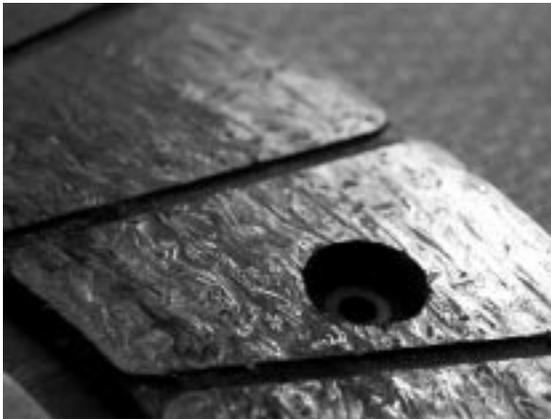
Burnt & Glazed Lining – Prone to Judder, Slip & Aggressive Wear.

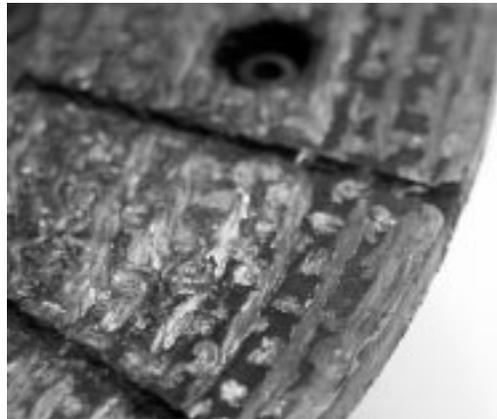
Carbonised lining – Resin Content vapourised. Prone to Rapid/Aggressive wear, Burst, Slip, Judder

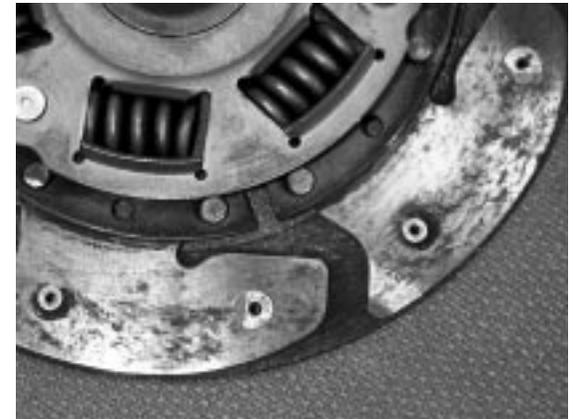
Cover Side Lining Disintegrated – A result of becoming carbonised.
